Manhole Inspection Summary

Manhole # S35AA1018MH

Location Address: **331 UNIVERSITY PKWY**

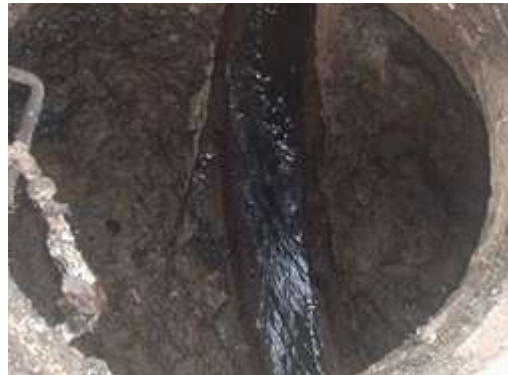
Top View

Corroded steps. Evidence of surcharge - Bench debris.

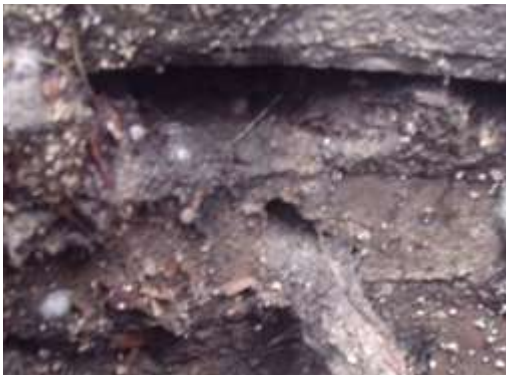
Defect

Condition: ☐ Sound ☐ Cracked ☐ Root Intrusion ☐ Loose Brick ☒ **Deteriorated**

Infiltration: ☐ None ☒ **Joint** ☐ Cracks ☒ **Mortar** ☐ Roots ☐ Wall

Adjustment deterioration and infiltration - other side.

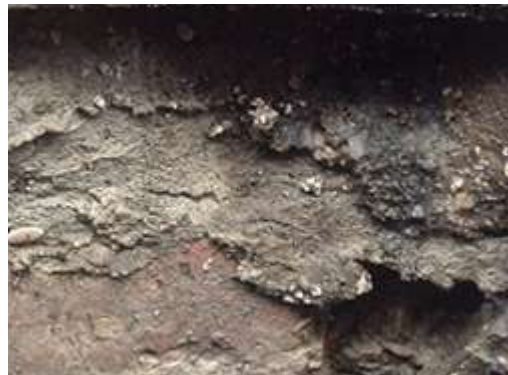
Defect

Adjustment deterioration and infiltration.

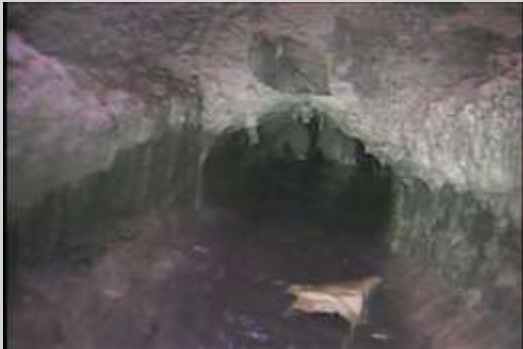
8 in. Circular Gravity Sewer Pipe Out @ 12 O'Clock

Deposits: ☐ None ☒ **Mud** ☐ Sludge ☒ **Debris** ☒ **Grease**

Silt Depth: **0.5** (in.) Deposits Extent: **Light**
